Reference Report n°: ASTEC- 014-2023

Project name: AMEC Foxhound Solar

Transformer: Serial number: 1050387107
Rating: 53 / 70.5 / 88 MVA
HV: 230000 GrdY/ 132791 V – 34500GrdY/ 19919 V
Internal Order: 150-1900212-2-2

INTERNAL INSPECTION AFTER FALIURE REPORT.

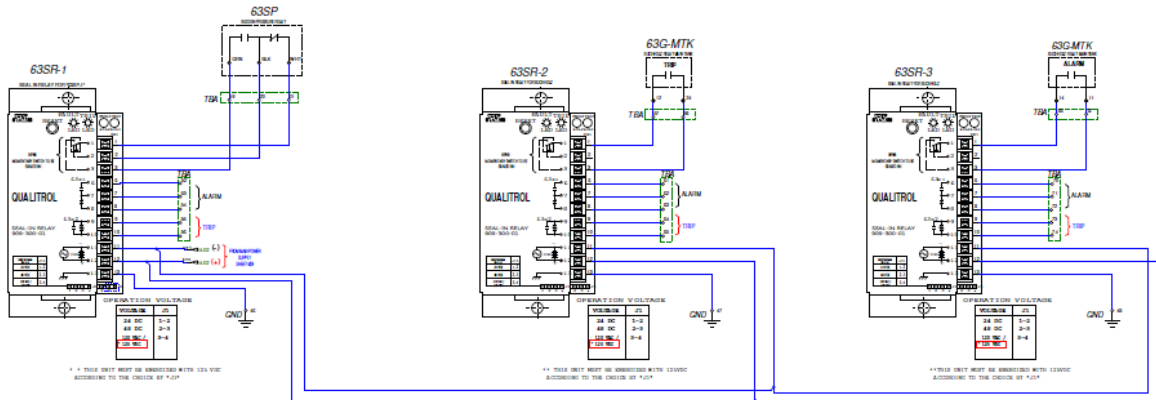
It should be noted that when reviewing the electrical diagrams, the seal relay 63SR-2 is connected to the trip of the Main Buchholz Relay (63G-MTK) and its alarm is connected to 63SR-3, and the sudden overpressure valve (63SP) is connected to relay 63SR-1, according to the following diagram:

That said, the relay that tripped was the 63SR-2, which means the event that caused the the unit to be off-line was detected by the main Buchholz relay.

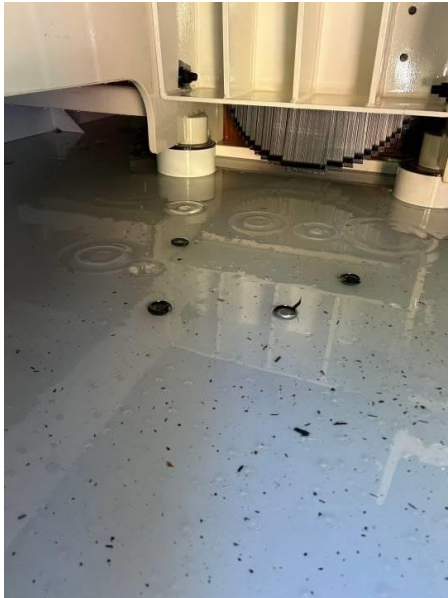
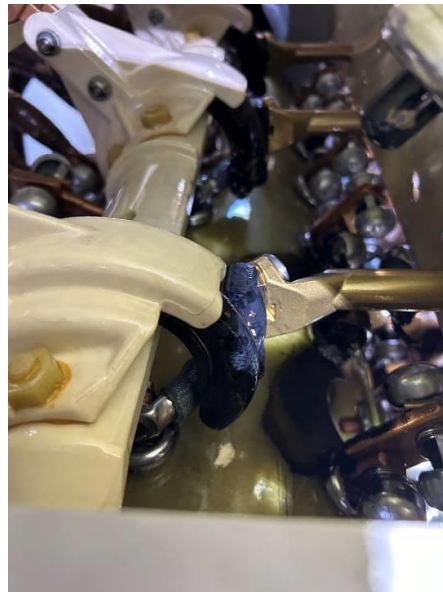
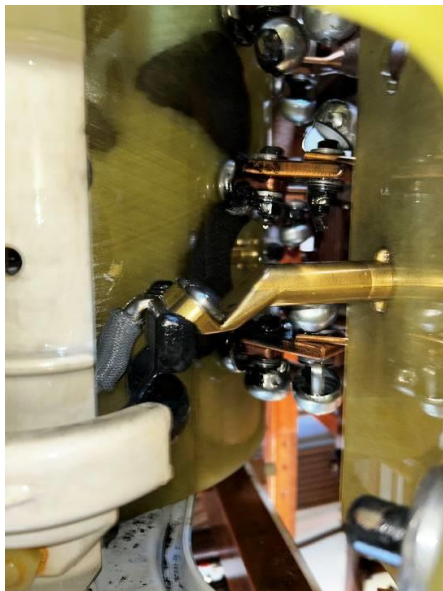
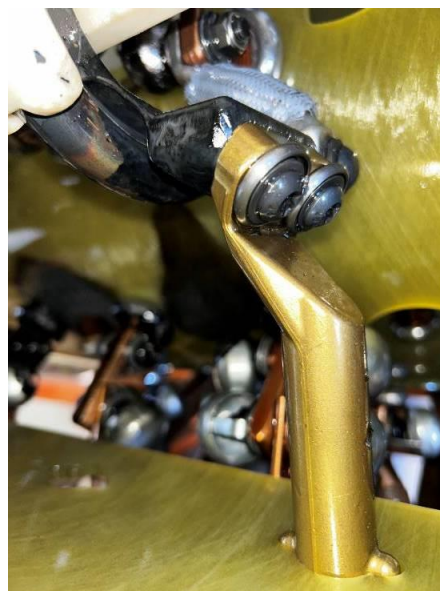
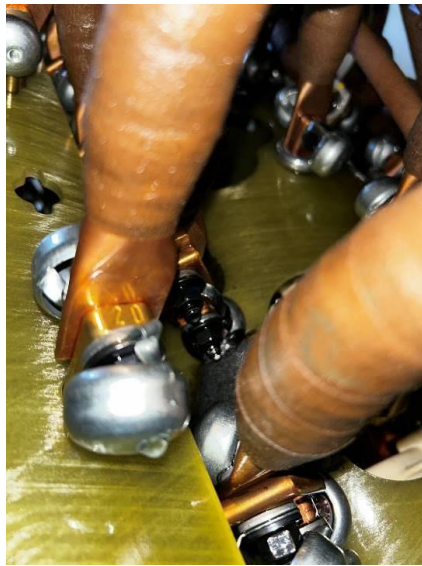
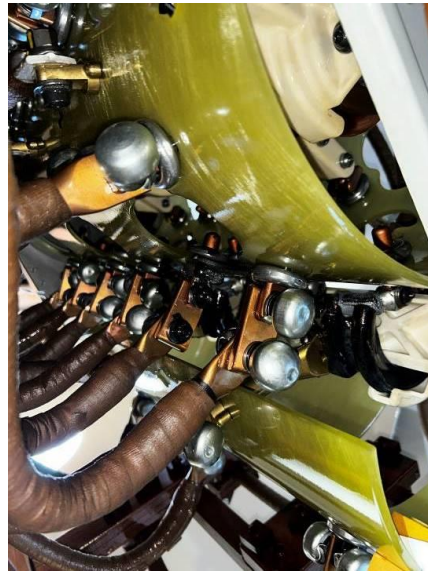
- WEG personnel, support Hitachi personnel to carry out the internal inspection
- The first comment today from the technician comments that the Selector was damaged and will need to be replaced, the Hitachi technician will send the evidence today to his specialist in Sweden.

3. It is observed a damage at the LTC, between terminals 7 and 16. As previously mentioned at this report, it is plausible to consider that the damages at the unit are restricted to the LTC.

4. Based on the evaluation of the damages, Hitachi indicates the LTC cannot be repaired. The replacement of this equipment is a complex operation to be performed on site. Based on that, it is stated that the transformer must return to WEG facilities, in Mexico, so this activity can be properly performed.

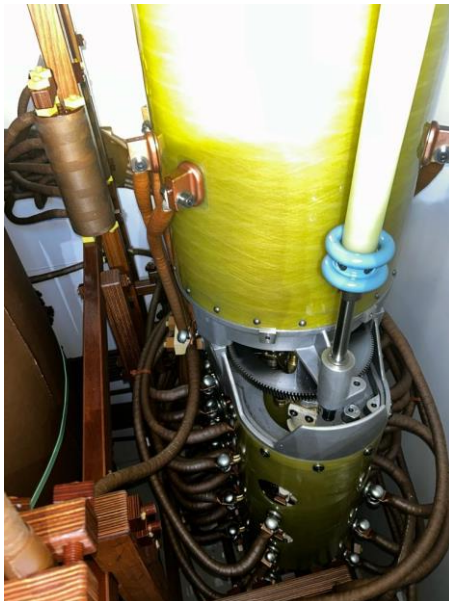
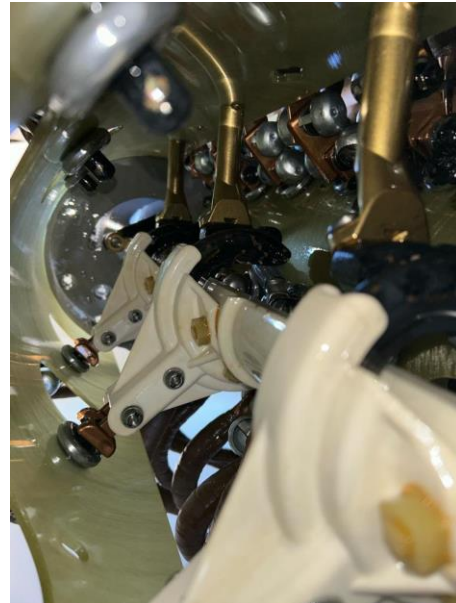
Test to the unit was perform in order to have the complete information from the unit. WEG and Hitachi informa to repari is not possible in site so the unit have to return to factory for repairs.
